Supplement Installation Instructions

H300 Entry / Comfort

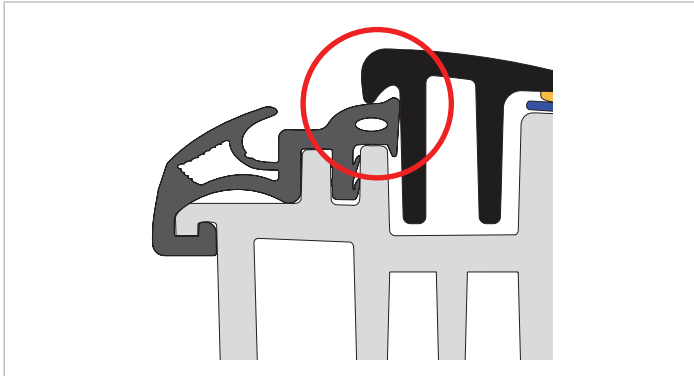
Water leakage caused by twisted main seal

If the main seal becomes twisted during the installation of the sunroof module, it can cause water leakage.

Fig. 01: Cross section of a correctly placed main seal

- ▶ Check the main seal for correct seal by inspecting it around the glass panel.
- ▶ Make sure the main seal is not twisted (see Fig. 01).
- ▶ In case of a twisted main seal, push the main seal gently under the roof molding using a plastic panel removal tool (see Fig. 02).

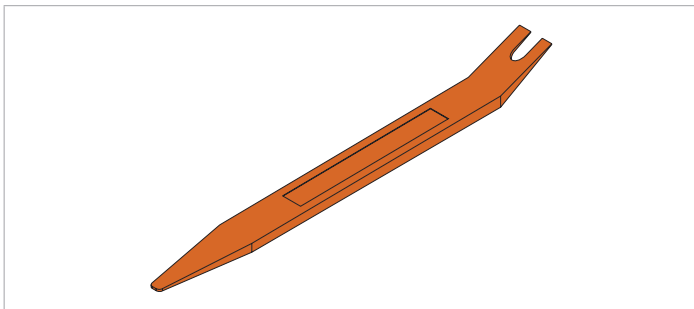
Fig. 02: Example of a panel removal tool.

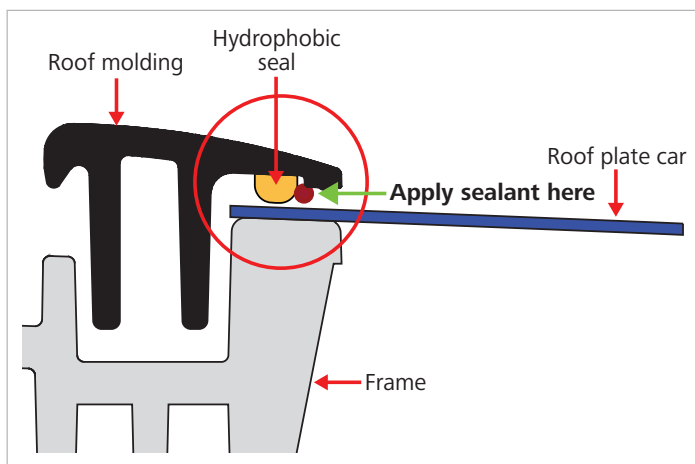
Water leakage caused by loose hydrophobic seal on roof skin

In applications with a strongly curved roof skin the hydrophobic seal can detach from the roof skin during cleaning the car with extreme high water pressure from a distance < 8 inch (200 mm).

Fig. 03: Location of additional butylane sealant

- ▶ Before placing the roof molding, apply a small layer of butylane sealant (or equivalent) at the edge of the front corners of the roof molding, outside the hydrophobic seal (see Fig. 03).

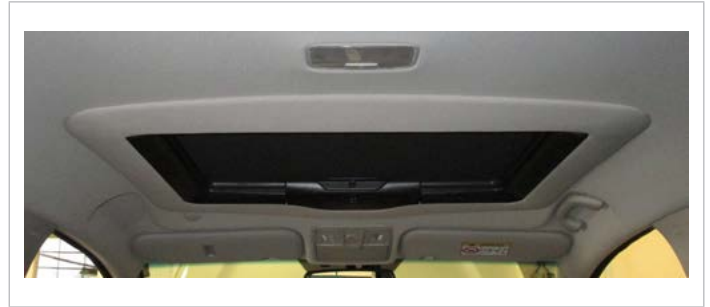
A gap between the trim-shell carrier and the original headliner is not acceptable.

Fig. 04: Properly adjusted trim-shell carrier

- ▶ Eliminate the gap (Fig. 04) by using the tips and tricks which can be found on the technical portal: dealers.webasto.com or www.techwebasto.com.

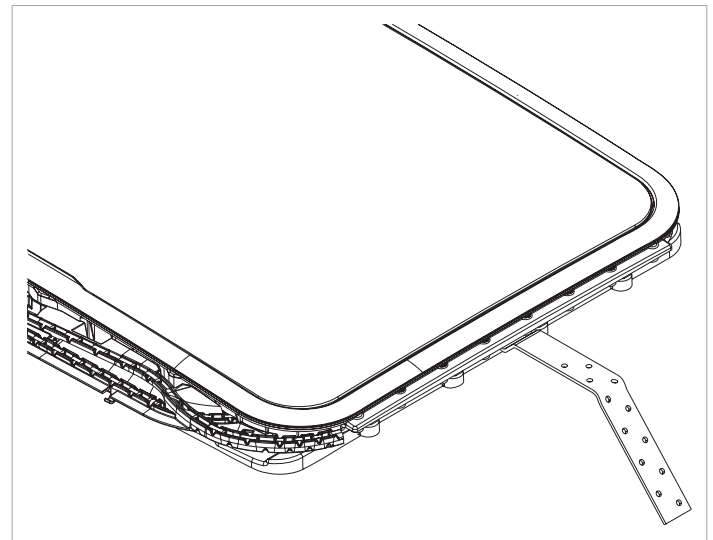
Some cars have a thin roof skin or there is much roof skin left on either side of the sunroof. This can cause vibration and / or collapsing of the roof skin.

Fig. 05: Support bracket placed to reinforce the car roof skin

- ▶ Install support bracket (Fig. 05) to reinforce the car roof skin. See the technical portal dealers.webasto.com or www.techwebasto.com for more information.
